**SUBJECT:** Change Order to Purchase Order #10219  
Power Generation Services  
SLP Unit 4 Turbine Generator Overhaul

**2006 - SLP Unit No. 4 Turbine Generator  
Overhaul Cost Matrix**

To: Wally Schlink and Lloyd Lynch, Rochester Public Utilities  
From: Troy Gehrett  
Re: Silver Lake Unit #4 Initial SPA Findings and Recommendations

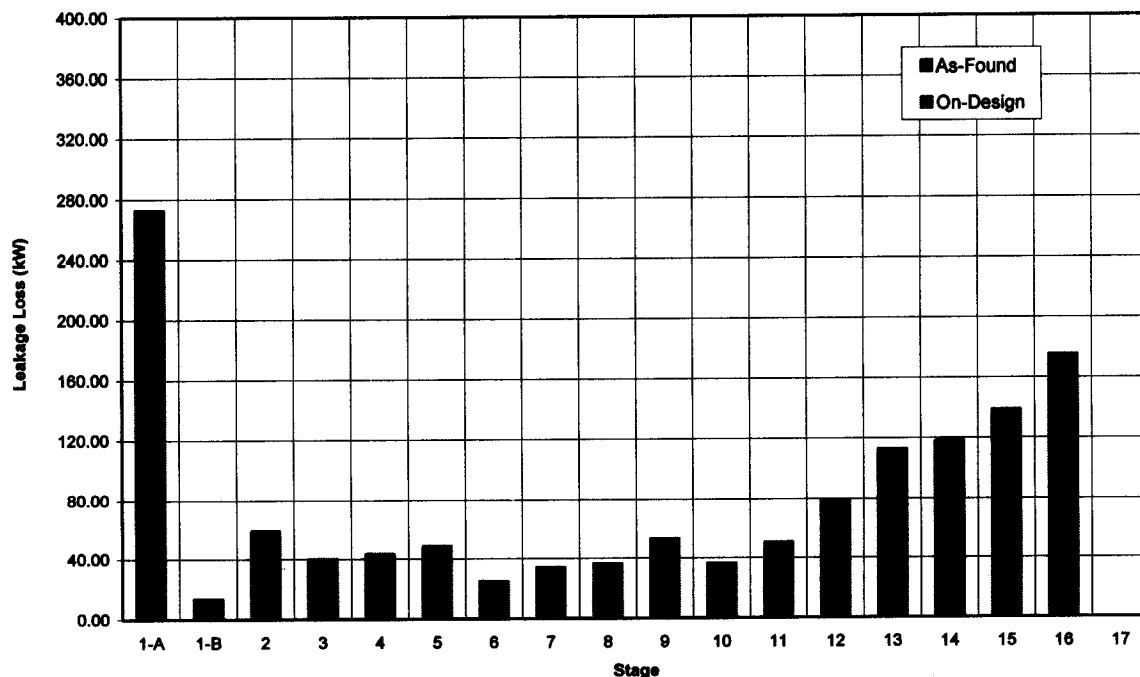
The greatest potential recoverable loss would result from the replacement of all of the spill strips in the unit (see *Figure 6* for details on stage by stage spill strip loss). This is estimated to produce an improvement of 541.14 kW, which is approximately 1.00% of the rated output for the unit. The second largest potential recoverable loss would result from the replacement of the HP gland seals. This would be estimated to account for an improvement of 516.25 kW, which is approximately 0.96% of the rated output for the unit.

*Figure 6 – Spill strip leakage loss breakdown by stage*

- If not repaired during this outage these partitions should be repaired during the next scheduled outage
14. Remove and replace spill strips in all stages of the unit
